## CIVIL AERONAUTICS BOARD

## ACCIDENT INVESTIGATION REPORT

COLUMBIA-GENEVA STEEL COMPANY, LOCKHEED LODESTAR, N 1245V,  
NEAR TYRONE, PENNSYLVANIA, DECEMBER 20, 1956

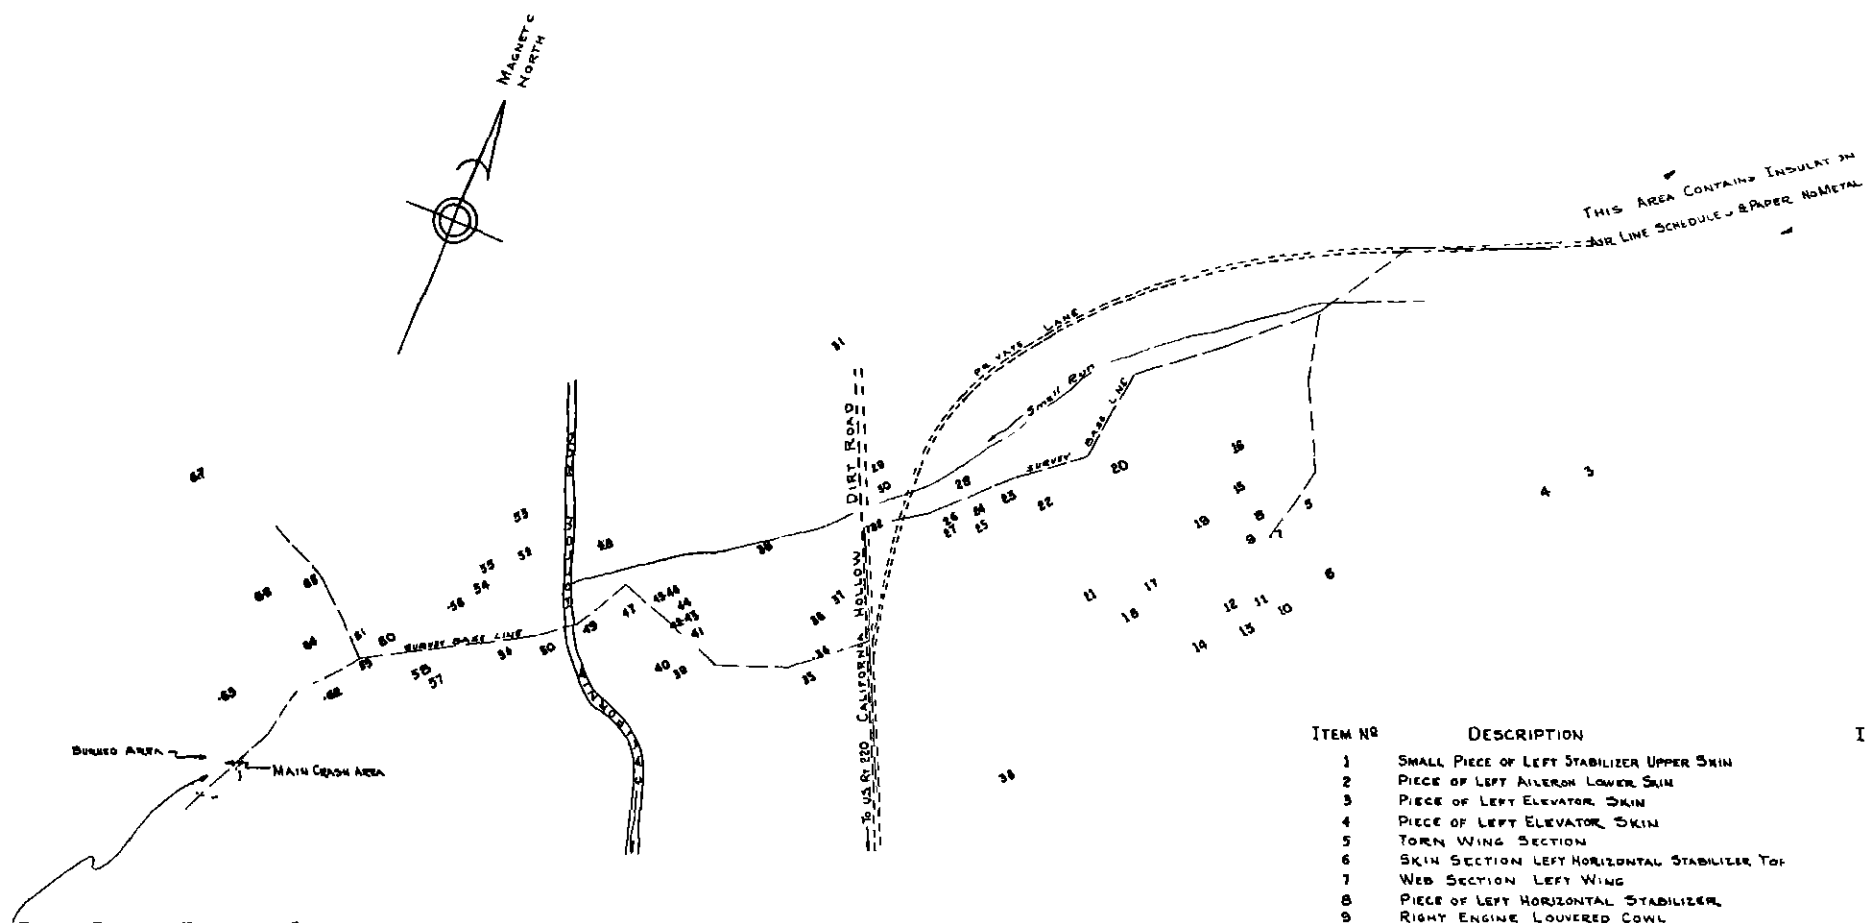
WRECKAGE DISTRIBUTION CHART  
 PREPARED FOR  
 CIVIL AERONAUTICS BOARD  
 AIRCRAFT ACCIDENT  
 UNITED STATES STEEL CORPORATION  
 LOCKHEED LODESTAR N12451  
 TYRONE, PA. DEC 20, 1956

The place of ground impact was in heavily wooded, rugged terrain, at an elevation of about 1,500 feet. The impact heading of the main wreckage was southwesterly, nearly a reciprocal of the destination heading. Numerous parts of the aircraft had separated in flight and these were found scattered for almost a mile in an easterly direction back along the flight path.<sup>3/</sup>

The major parts which separated in flight were: The left outer wing panel; the right outer wing panel outboard of the wing flap; the left and right fins and rudders; the left and right horizontal stabilizers and elevators; the aft fuselage rearward from the large window located just forward of the cabin door; and both powerplants. All other major components were found at the wreckage site. The landing gear and wing flaps were found in the retracted position.
